DESCRIPTION:

In the 1980s, the Canadian Air Force purchased a number of CL600 Challenger Aircraft for VIP transport and electronic war fare. These aircrafts were certified to the Federal Aviation Regulations (FAR) part 25. Specific CF requirements made it necessary to modify these aircrafts. Among other changes like avionics and wiring, cut-outs were made in the tailcone structure for an infrared sensor, a ram air intake, as well as a chaff dispenser.

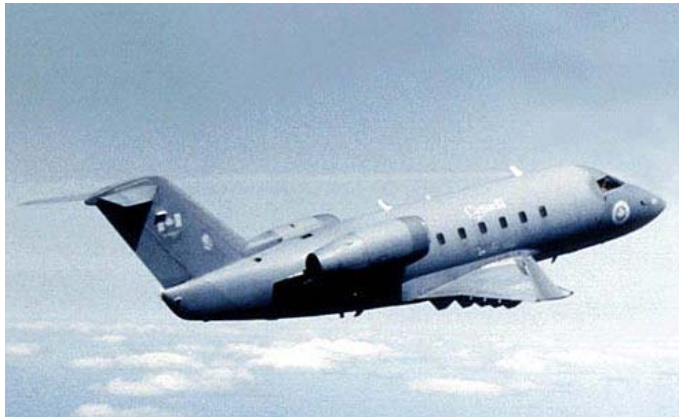
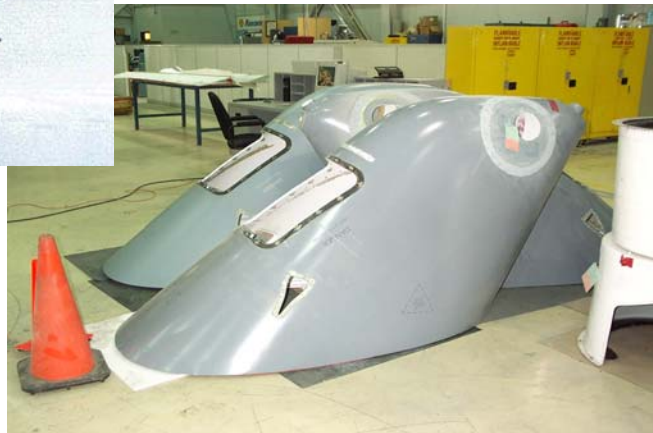
The tailcone structure consists mainly of Kevlar 49 prepreg material for the skins and Nomex honeycomb of variable thickness for the core material. Local ply-build ups and changes in core thickness are used to account for local loads in the tailcone design.

After the CF decided there was no further need to operate the CL600 Challenger aircraft, three CL600 aircrafts were sold to a private operator who contracted out the removal of the modifications installed by the CF. The contractor was tasked to re-certify these aircrafts to FAR 25. The cut-outs remaining after removal of the tailcone modifications were considered as damage and repair schemes had therefore been developed to re-establish the structural integrity of the original tailcones. Martec Limited was therefore tasked by the contractor to analyze the proposed repair schemes and to modify the repair schemes as required to ensure the structural integrity and durability of the repairs.

The proposed repair schemes were analyzed and modified as required ensuring the structural integrity of the tailcone structure for the environmental conditions in which the aircraft operates. Technician experience as well as inspection limitations were considered in the repair design and analysis, providing a sufficient margin of safety. The performed analyses were based upon traditional classic lamina analysis theory (CLA), basic engineering methodology, as well as lamina analysis software. The repairs were executed by the contractor and the aircraft has successfully been re-certified to FAR 25.
